## KTA-TATOR, INC.

November 16, 2010  
Via Email: [tony@epox-z.com](mailto:tony@epox-z.com)

**SUBJECT: Accelerated Weathering Exposure of Epox-Z Industrial Coating;  
KTA-Tator, Inc. Project 300381-Addendum**

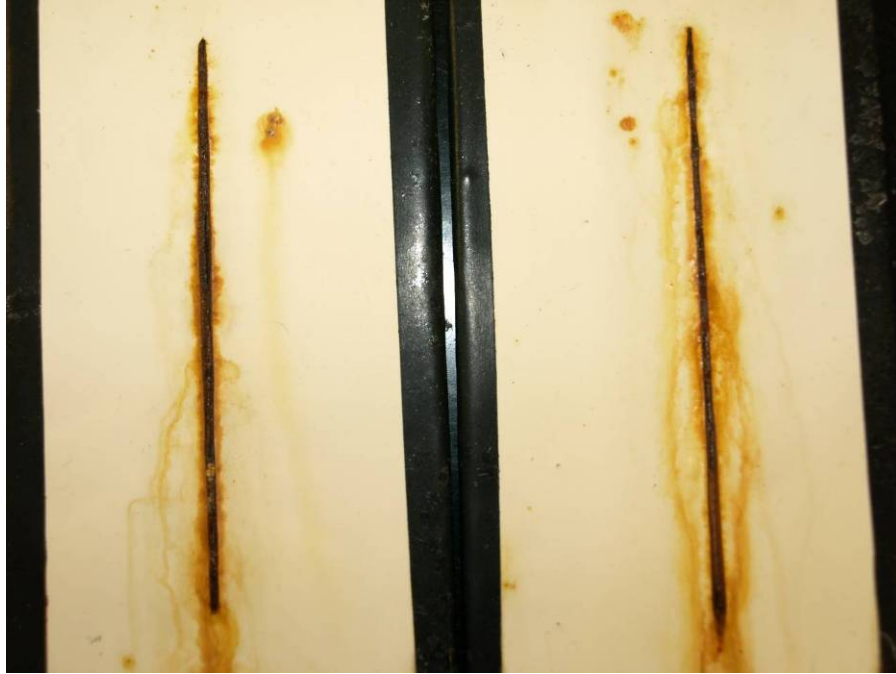
Exposure Time	Rust Staining	Rusting	Blistering	Comments
500 hours	None	None (10)	None (10)	Off-white
1000 hours	$\frac{1}{16}$ " from scribe	Occasional pinpoint (10)	None (10)	Loss of gloss
1500 hours	$\frac{1}{16}$ " – $\frac{1}{4}$ " from scribe	Occasional pinpoint (10)	Face, 10*	No gloss on surface

\* Some blistering at scribe. May be due to corrosion undercutting of  $\sim \frac{1}{4}$ " from scribe line.

**KTA-1 and KTA-2 Following 1500 Hours Exposure to Cyclic Weathering**

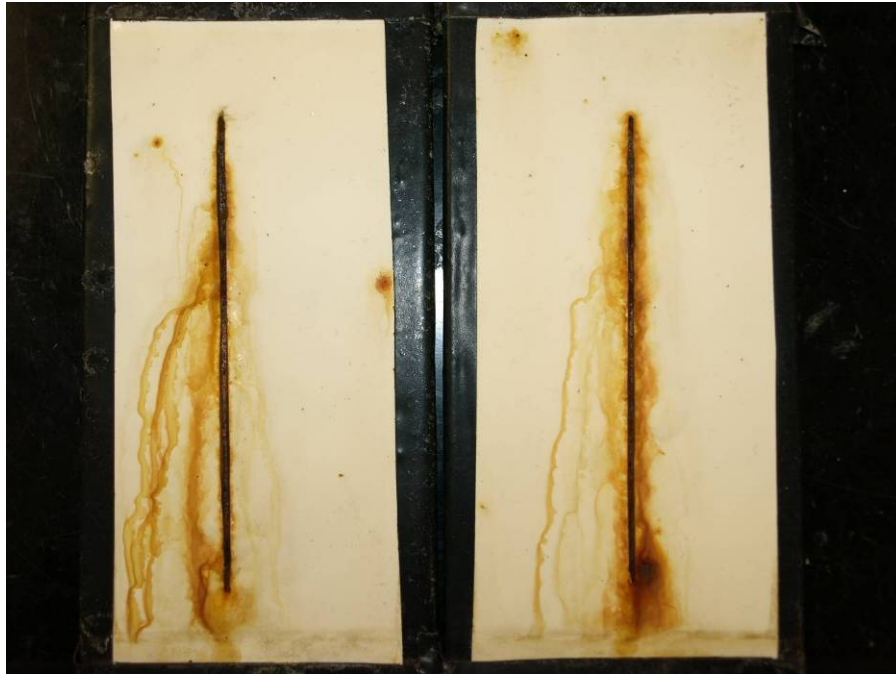
**KTA-3 and KTA-4 Following 1500 Hours Exposure to Cyclic Weathering**
