TECHNICAL BULLETIN

METAL BUILDING ROOFS

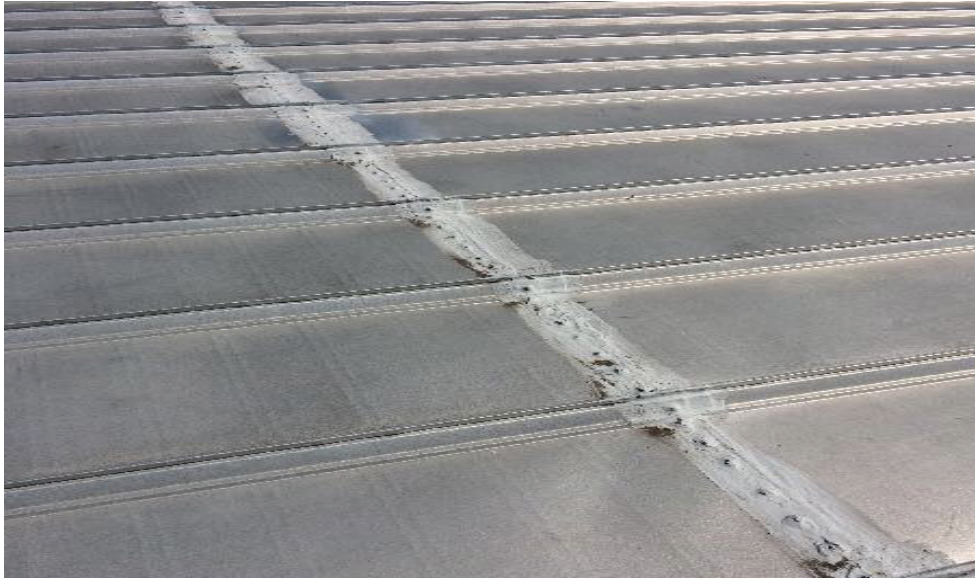
Opening of Horizontal Seams

Metal roof restoration consists of a specific series of steps. These steps must address fastener replacement as well as flashing and seam repair. The application of EPOX-Z High Performance Cool Roof Coating will complete the restoration project and provide years of reliable service.

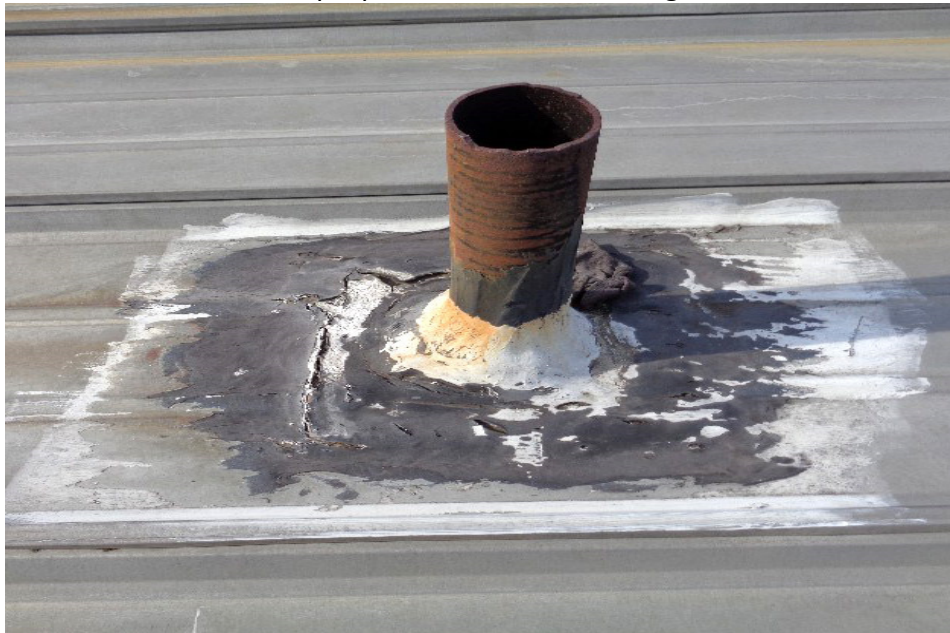
Improper Penetration Flashing

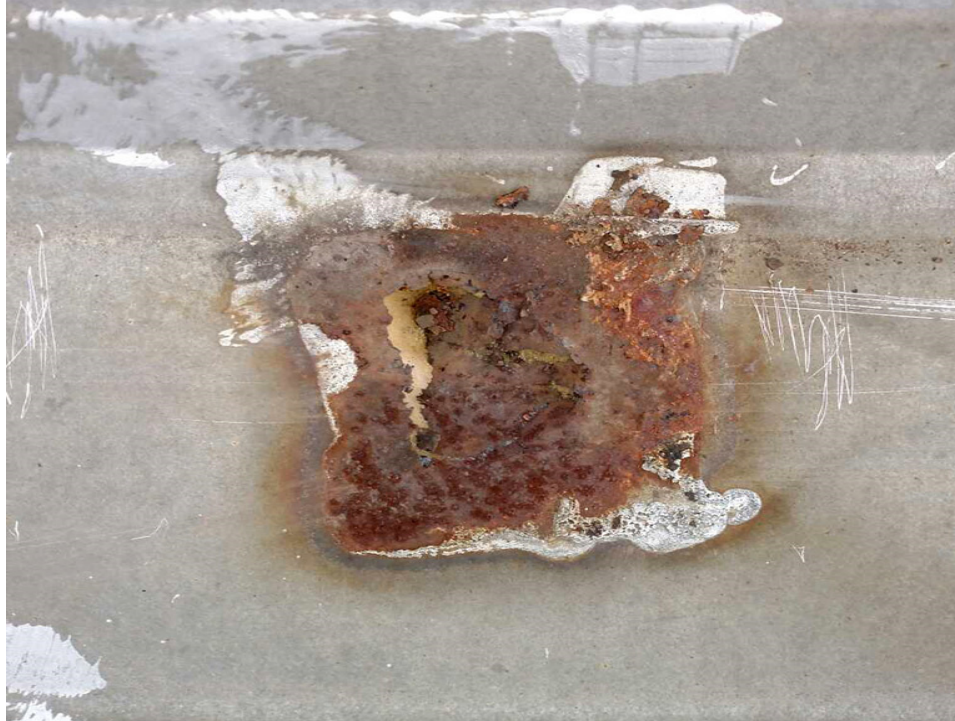
Metal Panel Oxidation

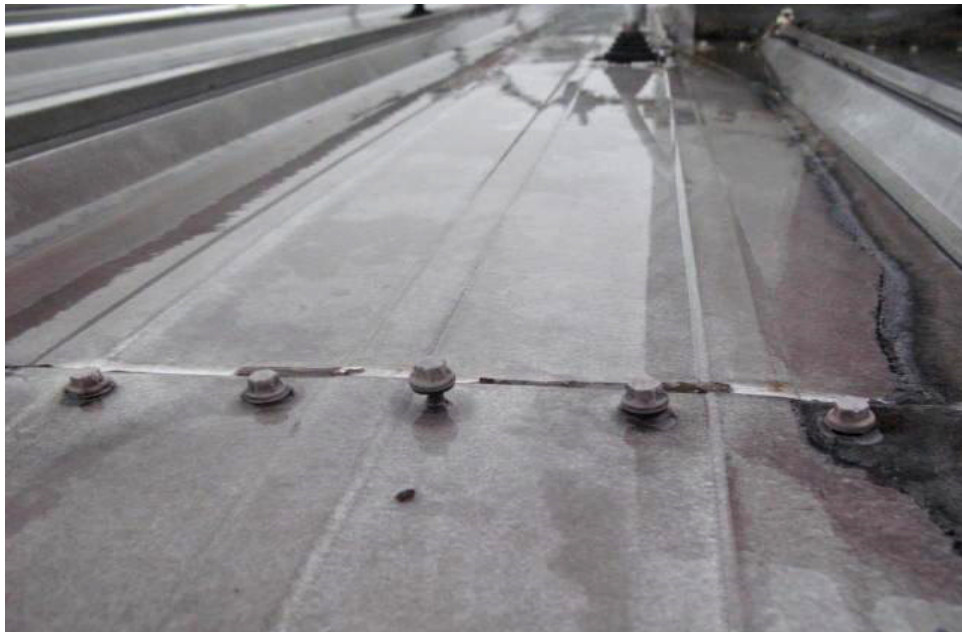
Fastener Back Out

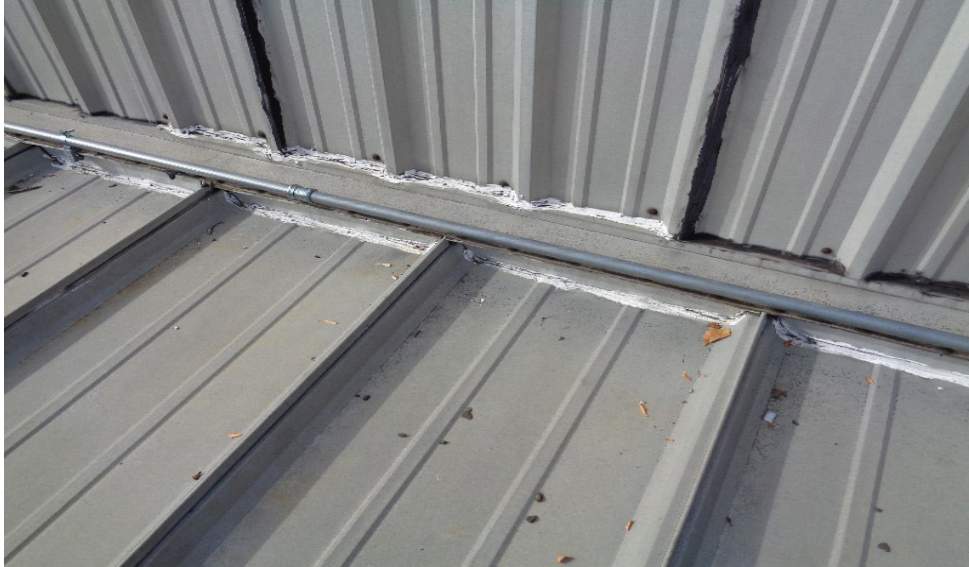
Failed Headwall Flashing
